STATE OF CALIFORNIA
BUSINESS AND TRANSPORTATION AGENCY
DEPARTMENT OF PUBLIC WORKS
DIVISION OF HIGHWAYS

THE EFFECT ON STATE HIGHWAYS
OF
THE SAN FERNANDO EARTHQUAKE
FEBRUARY 9, 1971

SEPTEMBER 1971
SUBMITTED PURSUANT TO SB 682

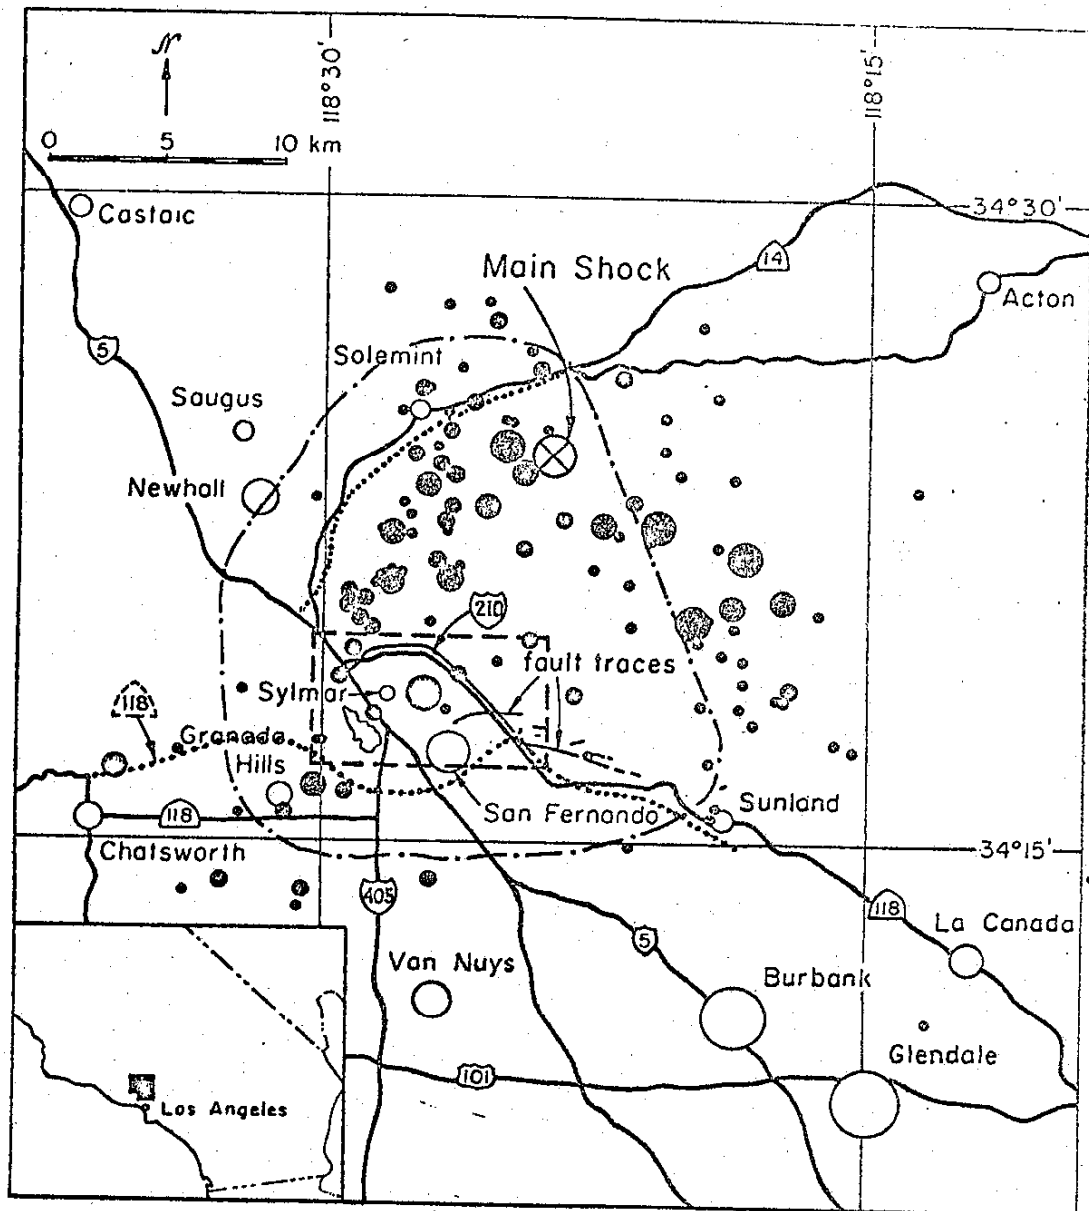
Figure 1 GENERAL AREA OF FIELD STUDY,
MAPPED AREA, AND AFTERSHOCKS

Geographically, the epicenter is some 25-30 miles northwest of the Los Angeles Civic Center, or seven miles east of Newhall, as shown in Figure 1. With reference to damaged roads, the epicenter is located about eight miles northeast of the Route 5/210 Interchange and about two miles south of Route 14 near Soledad Canyon. Focal depth has been determined to be about seven miles. (See item E, Tectonic Movement).

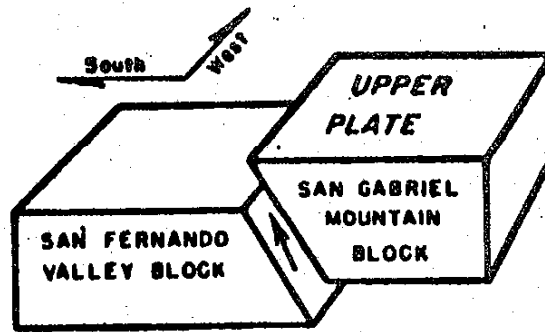
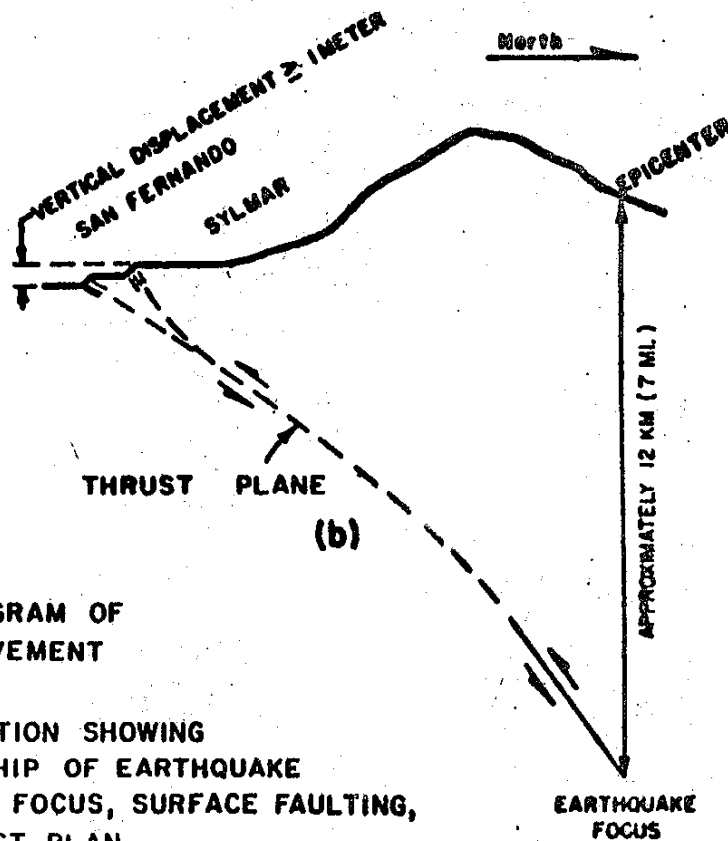
Figure 2 BLOCK DIAGRAM AND CROSS SECTION OF FAULTING
AFTER R. GREENSFELDER
SEE VI REFERENCE *2, p. 64

Regional tectonic movement consisted of an upper plate (Figure 2a), more or less delineated by the inverted "U" shape formed by the aftershock locations shown in Figure 1, that moved to the south and west along a thrust fault plane dipping about 45° to the north. This upper plate moved over the lower plate as rupture progressed along the thrust plane from the hypocenter to intercept ground surface in the Sylmar-San Fernando area. Because of the shallow fault depths and large ground displacements, this was the area in which damage to engineering works was concentrated.
